Tesi di Laurea specialistica sperimentale

**The effect of weathering on slope instability**

The Marbrière versant, Grasse, Alpes Maritimes, France

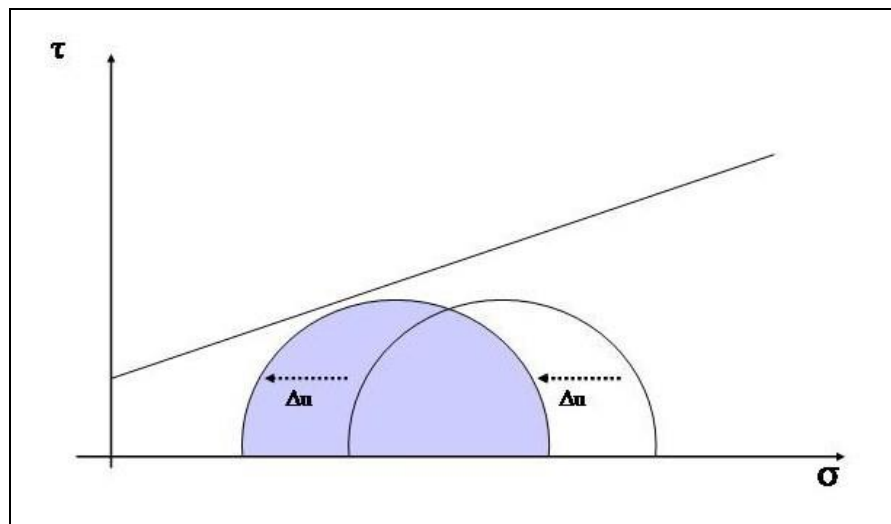
Figure 1 : Modification of the intergranular stress represented on the Mohr circle (Desvarreux in Lebourg, 2000)

- **Hydrostatic effects:** During the augmentation of the piezometric level, an augmentation of the hydrostatic pressure takes place in the ground. This augmentation of pressure ( $\Delta U$ ) leads to a modification of the stress state of the grains and to a shift of the moor circle towards the envelop-rupture curve (in case of a weak behaviour). (Figure 1) The capillary effect described above is maintained.
  -

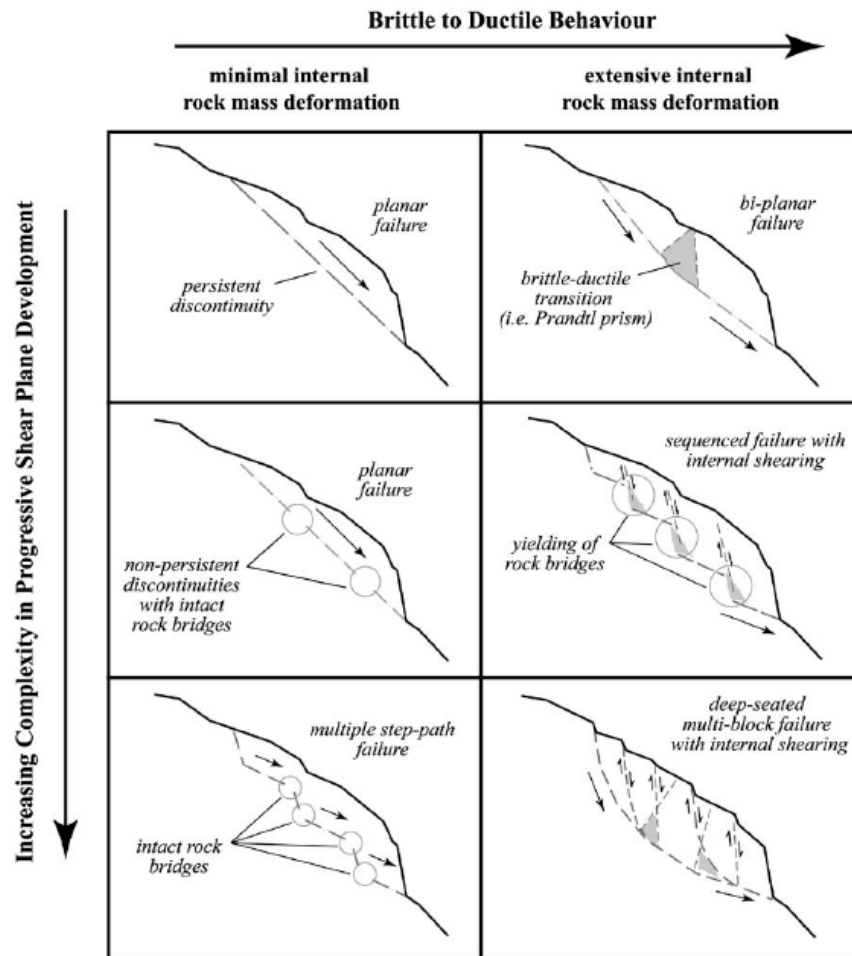
**Figure 2 : rupture mechanism of a rocky versant in function of its geologic discontinuities that pre-cut the massif, Eberhardt and al, 2004, in El Bedoui, 2009)**

The concept of progressive rupture can therefore be preliminarily defined as the propagation of the internal fracturing of the versant in time.

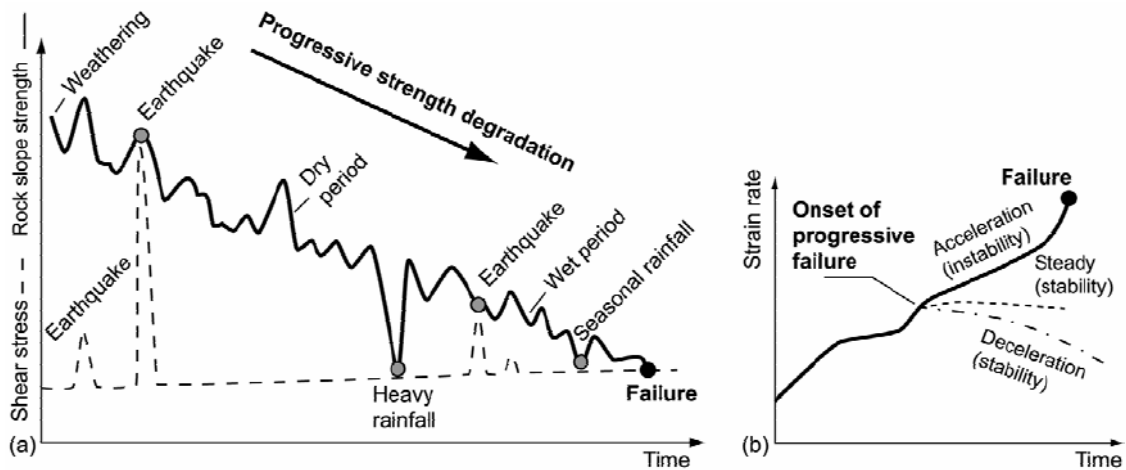
Figure 3 : (a) conceptual evolution of the mechanical resistance of a versant during the progressive rupture, (b) Evolution curve of the rate of deformation in function of time for a versant submitted to progressive rupture. (after Finlayson and Staham, 1980 in El Bedoui, 2009)

Because of this spoiling progressively smaller external solicitations (climatic or tectonic) can accelerate or provoke the destabilisation of the massive.(Figure 3a) In Figure 3b different scenarios for a rock-mass subject to progressive rupture are proposed: (i) a final acceleration that leads to rupture, (ii) a stationary state, (iii) a stabilisation. These different evolutions are dependent on the internal conditions of the versant and on the external solicitations.

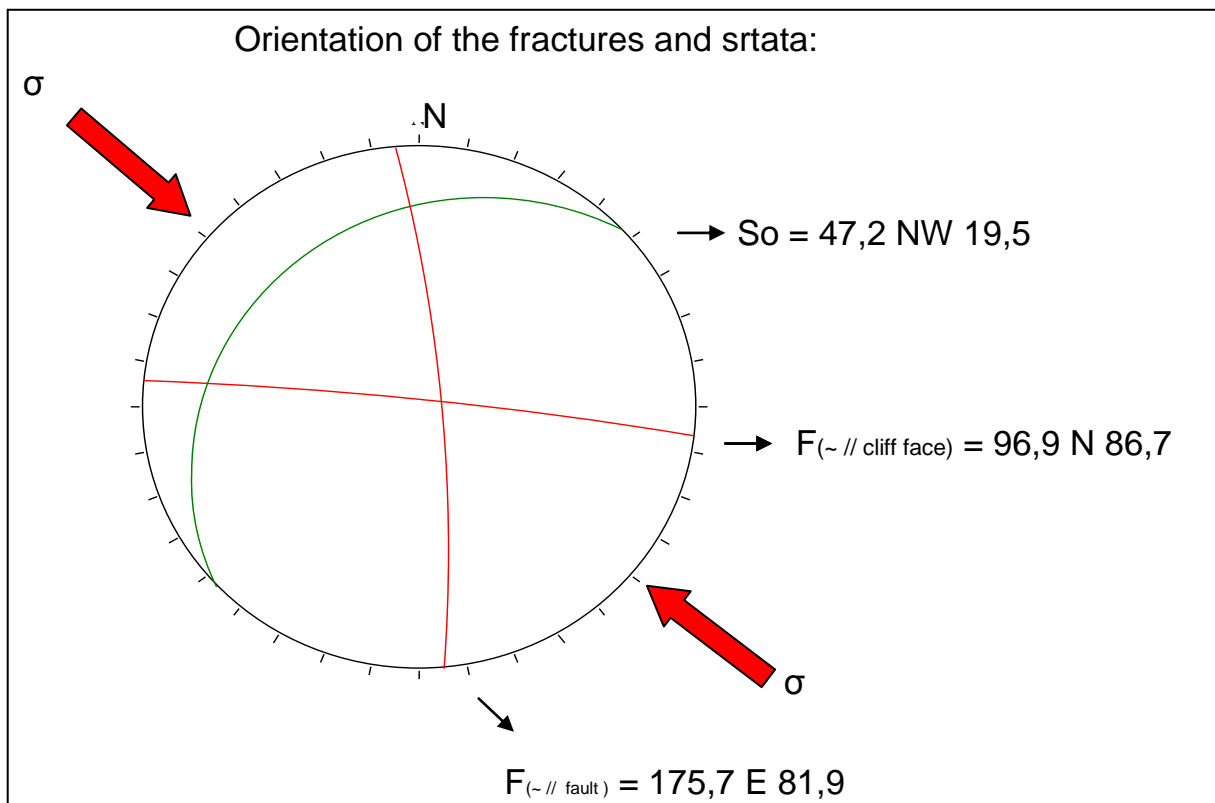
Figure 10 : Stereo plot of mean orientation of fractures and strata of the cliff face on Wulf canvas, lower hemisphere.

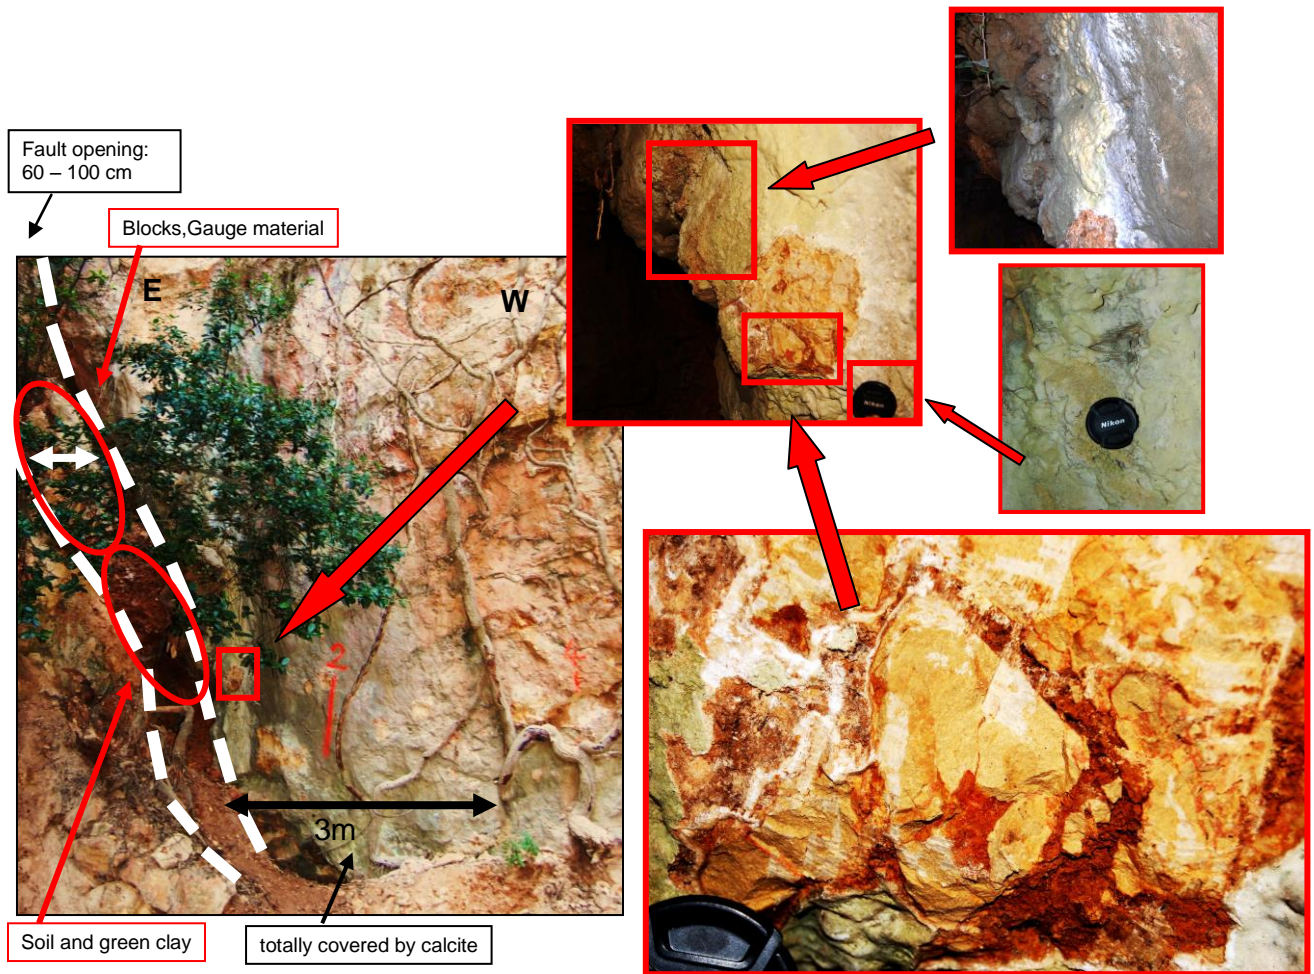
**Figure 15 : Visual description of the fault and the first 4m of the cliff face which are completely covered by calcite**

- The first 3 meters starting from the fault were strongly covered with calcite. On the very first meter thick pockets of calcite have been observed, whereas a layer of about a cm covers the cliff face from meter 1 to 3. This does not only complicate the measurement of the SHRV, but it also hides the fractures and micro-fractures of the rock, which makes the evaluation of the apparent joint separation impossible on the first meters. To overcome this inconvenience on the first meter the calcite has been removed on various spots with the geological pick, uncovering a cataclastic rock. A matrix of totally altered, from orange to red and very porous rock material is crossed by small veins of calcite and contains discoloured blocks in which the original mass structure is still visible. The geological pick easily indents in the reddish matrix which can as well be easily crumbled by hand, whereas the discoloured bocks do not crumble by hand and the point of the geological pick scratches the surface but does not easily indent.

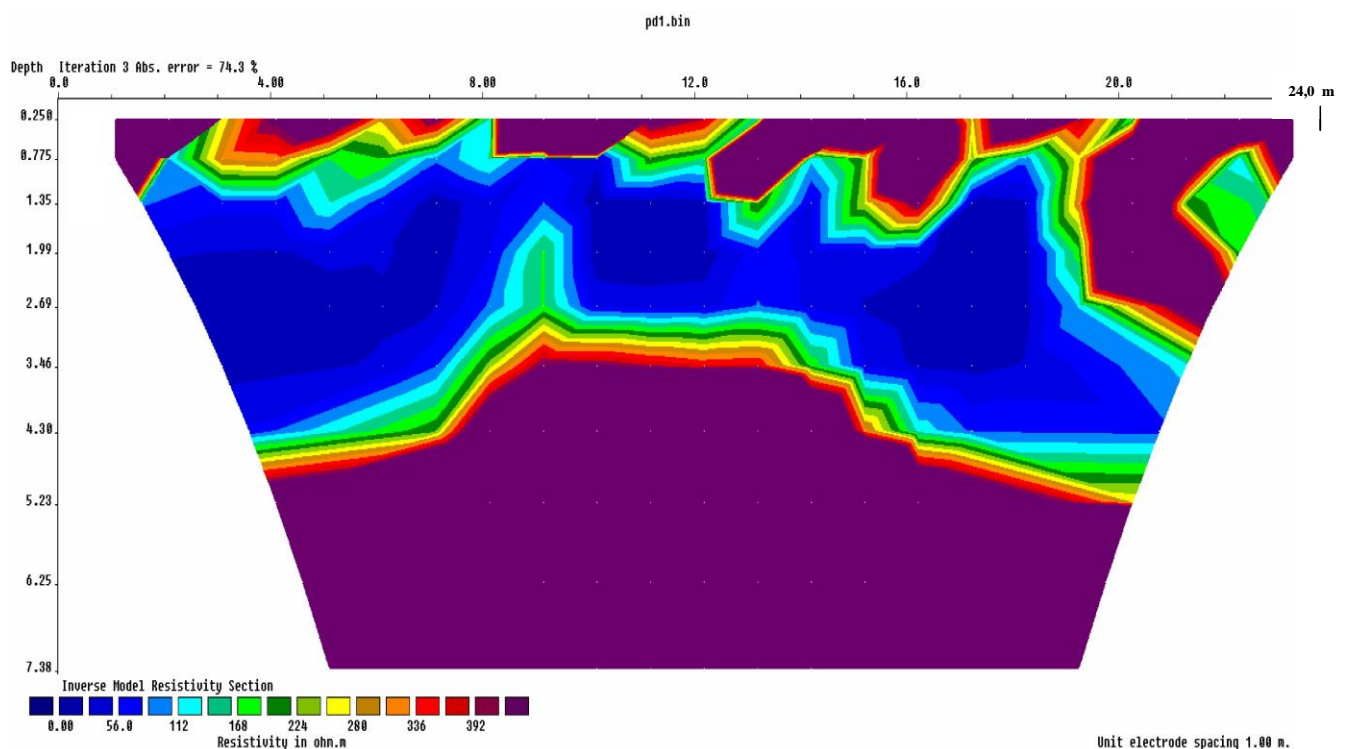
Figure 17 : Inversed horizontal electric profile on the cliff face. (Rms=74,3%)

Although all these problems cause a too high RMS an interpretation of the profile is proposed:

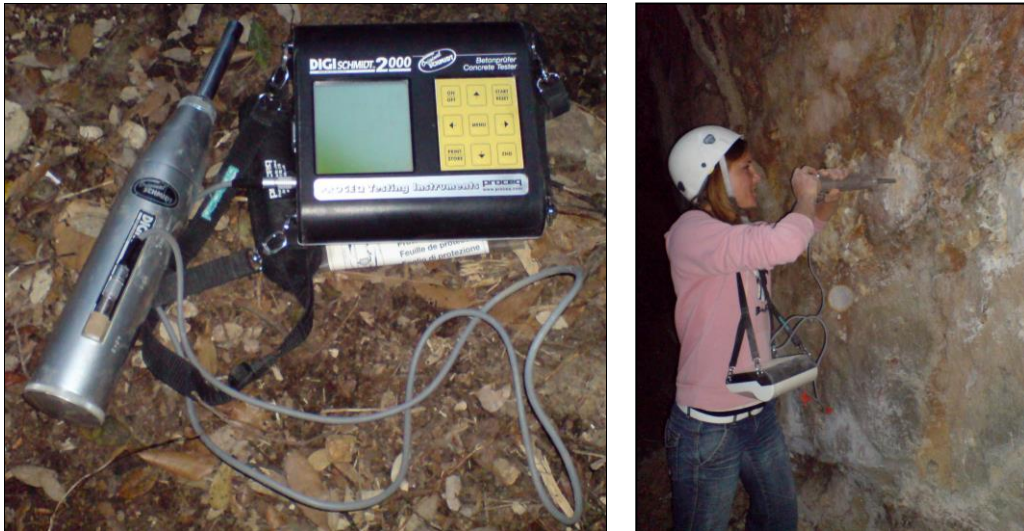
**Figure 21 : Schmidt Hammer « Original Schmidt, N Type » (left), operator using the Schmidt Hammer on the cliff face (right)**

The rebound value (SHRV) was measured on the same layers with a Schmidt hammer: Original Schmidt, N type (Figure 21)(Characteristics in Annex)

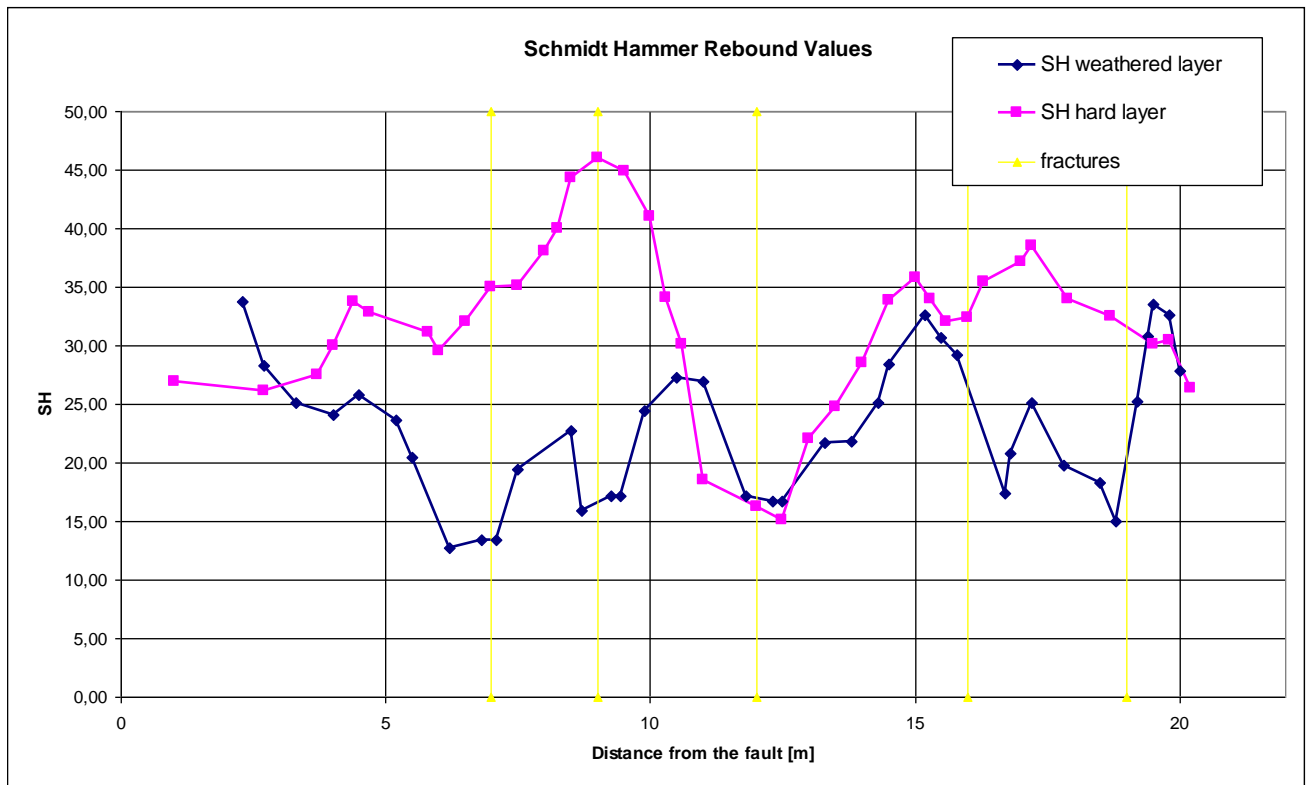
Figure 23 : Schmidt Hammer Rebound Values in function of the distance from the fault

The results of the first test series on the weathered layer regrettably produced results that would mislead the analysis: It was not always easy to take away a whole part of rock from the surface and it was necessary to use a chisel and a hammer. In this process the underlying rock has visibly been damaged and many micro fractures were induced. Therefore the SHR<sub>V</sub> were very low (~15) and sometimes it was so low that the test machine did not even register the result. Using this data would distort the results of the analysis since the tests were carried out on recast and not on untouched rock material. Therefore only the results of the tests that were carried out on the polished, superficial rock are plotted in Figure 23 and discussed in the following paragraph:

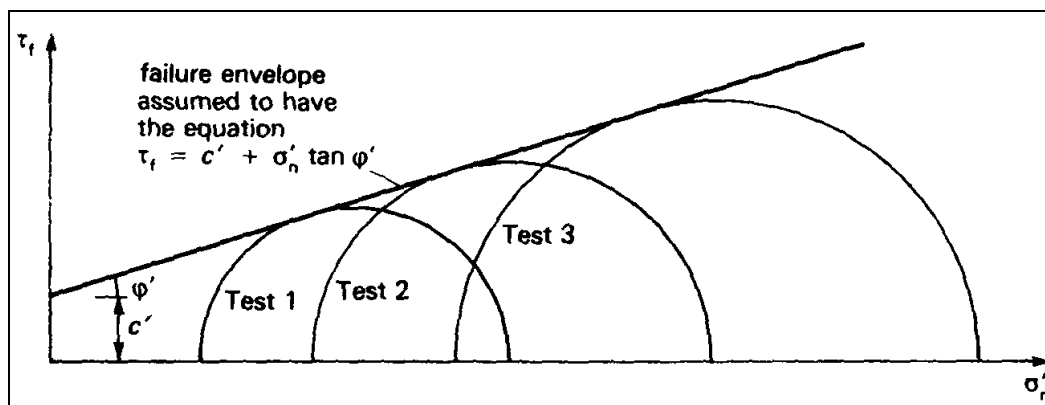
Figure 26 : Calculation of  $c'$  and  $\phi'$  by using triaxial test results (after: Geotechnical Engineering Laboratory, CE 3121, Texas tech. University)

Soil specimens are loaded to failure under 3 different confining pressures. Failure will be defined as the peak or maximum value of the reached deviator stress (ASTM D2850). Using Mohr diagrams of these experiments, the shear strength components of the sample can be estimated (Figure 26).

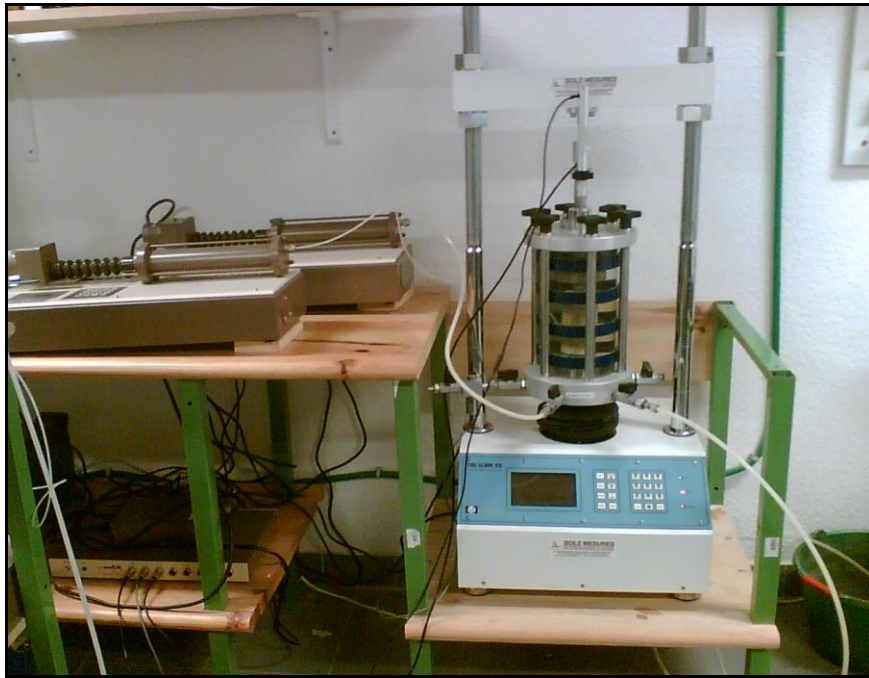
Figure 28 : Triaxial compression test equipment

For these experiments, we have used triaxial compression test machine (Heavy Duty Banded Triaxial Cells, Wykeham Farrance ) (Figure 28).

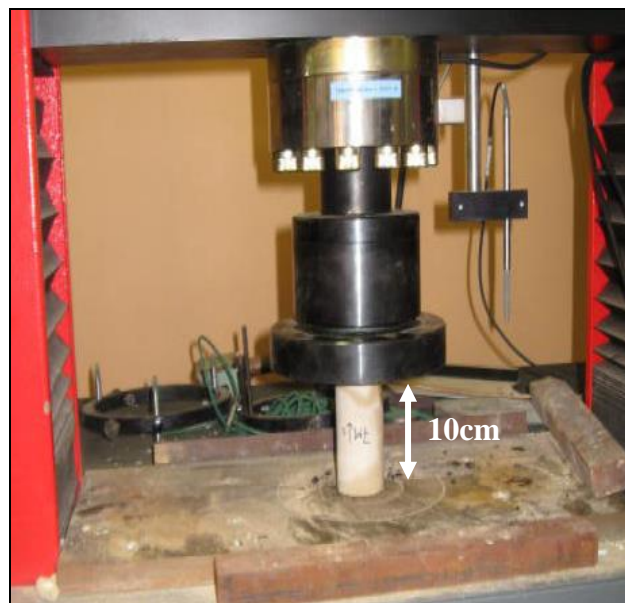
Figure 32 : UCS test with IGM Press with a 300kN captor.  
Specimen  $h=10\text{cm}$ ,  $\varnothing=5\text{cm}$

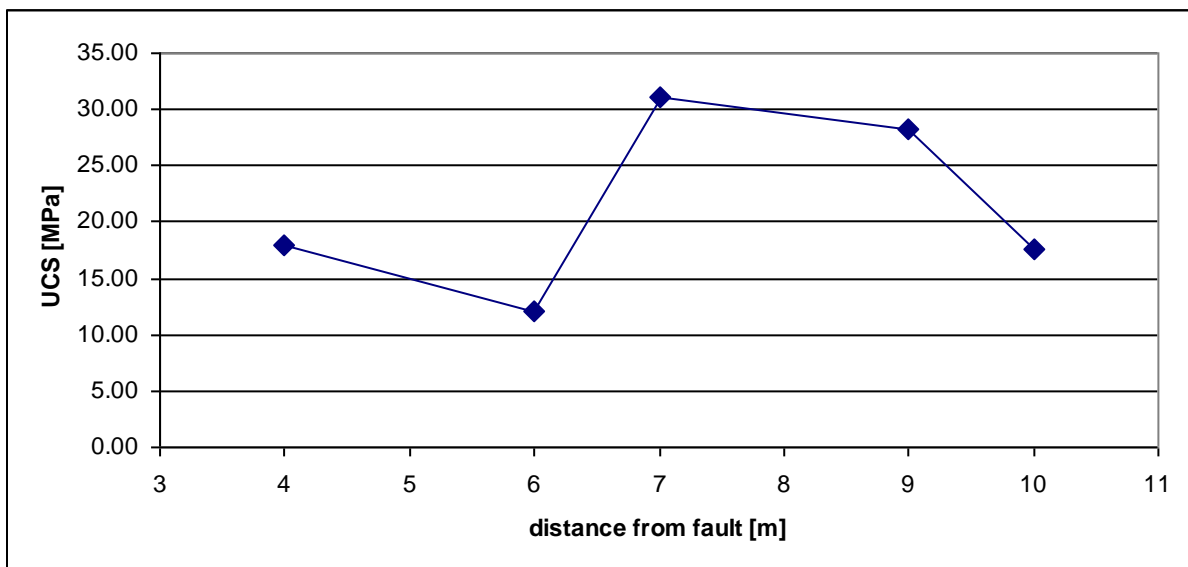
Figure 33 : UCS of the drill cores B in function of the distance from the fault

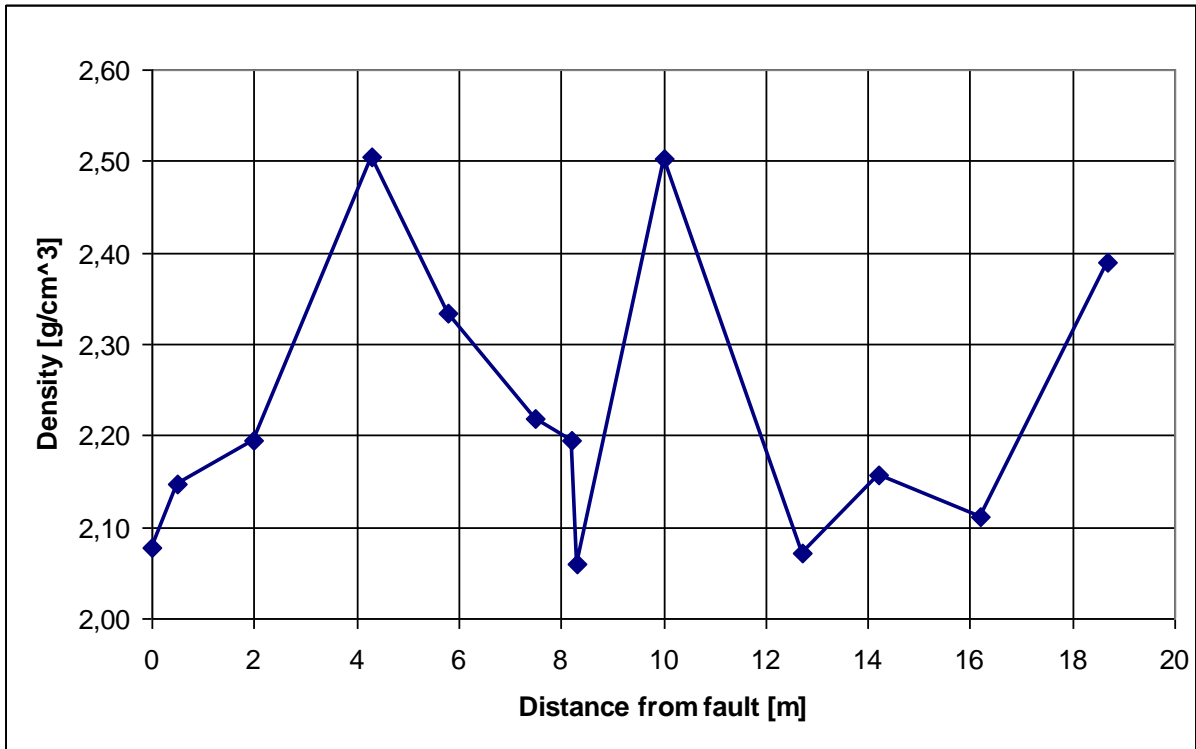
Figure 40 : Drill Cores A: Density in function of the distance from the fault

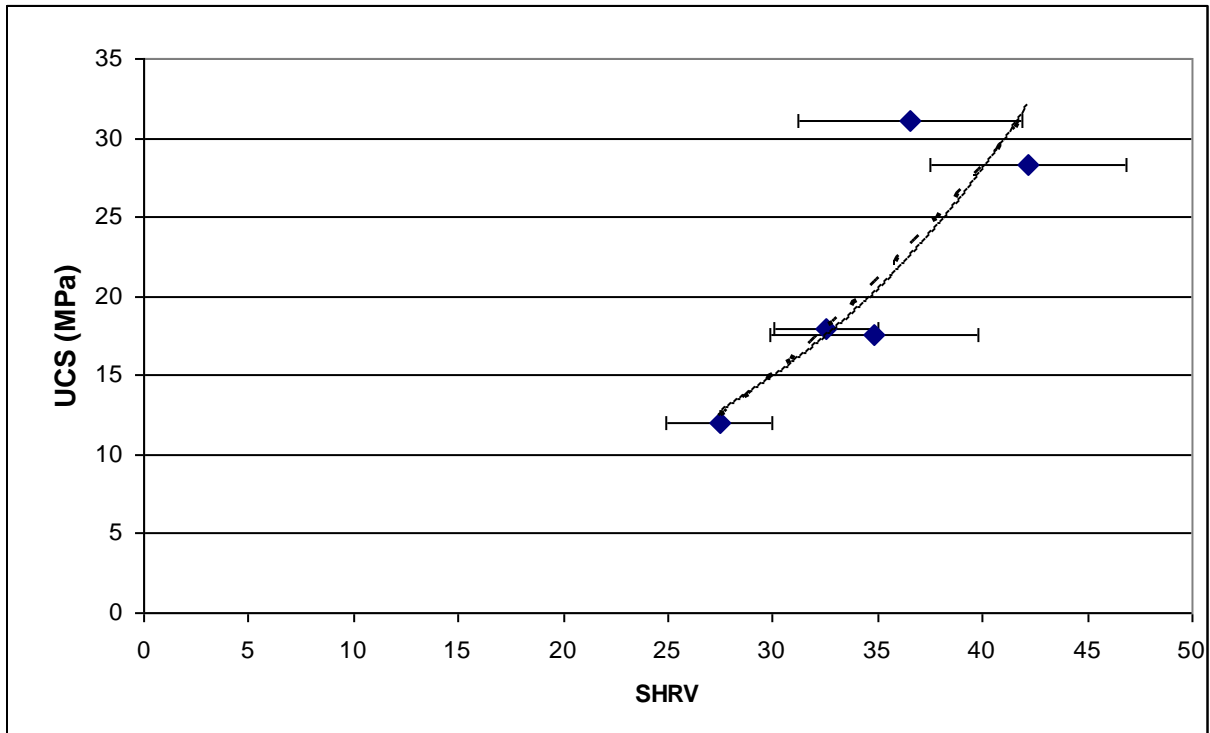
Power law -----  $UCS = 2,2899 * e^{0,0627 * (SHRV)}$   $R^2 = 0,76$   
 Exponential law - - - - -  $UCS = 0.0091 * (SHRV)^{2.1778}$   $R^2 = 0,79$

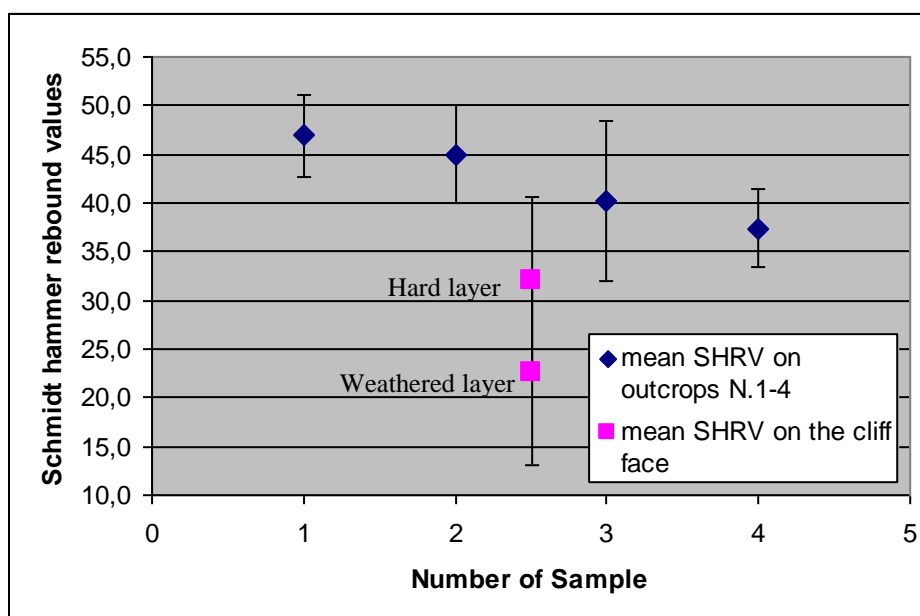
**Figure 54: Mean SHRV for each sampled outcrop N°1-4 and for the hard and weathered layer on the cliff face**

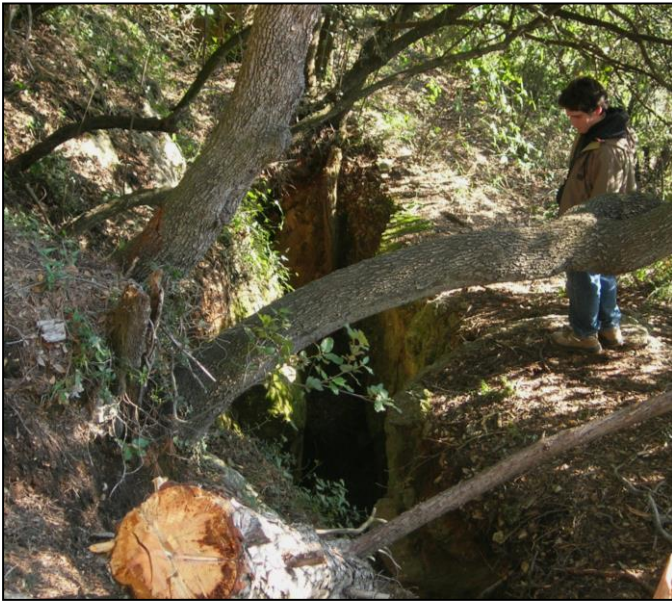
Figure 56 : One of the crevasses (N40°) on the Marbrière versant a few m under the Foulon channel.
